Chinese Binary

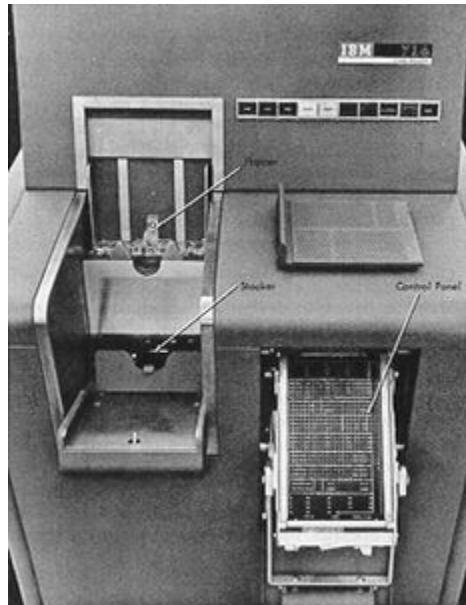
IBM 714 Card Reader

The 714 read brushes connect to a winding around a magnetic core. When the brush goes through a hole in a card it touches the contact roll, which is connected to 48 volts DC. This voltage causes current to flow through thru the brush and core winding setting the core to a 1 bit. I decided to scope one of the read brushes to see what the signal going to a core looked like. That's when I got a surprise. Instead of seeing a 48 volt pulse from the contact roll it was only 27 volts. I put the scope on the common brush that fed the 48 volts to the contact roll and saw 48 volts until the row of holes in the card passed under the brushes then it dropped to 27 volts. I followed the wire that fed the common brush back to a terminal block and found a solid 48 volts there. All those holes in the card was causing so much current to all those cores it was dropping 21 volts across the wire from the terminal block to the common brush. The machine needed a bigger wire.
